REPORT ON RIVER GAGE STATION

LOCATION: Portola
STREAM: Middle Fork Feather River
BASIN: Feather River HSA: REV

LOCATION IDENTIFICATION: MFTC1
NWS INDEX NUMBER:
USGS NUMBER: 11392100

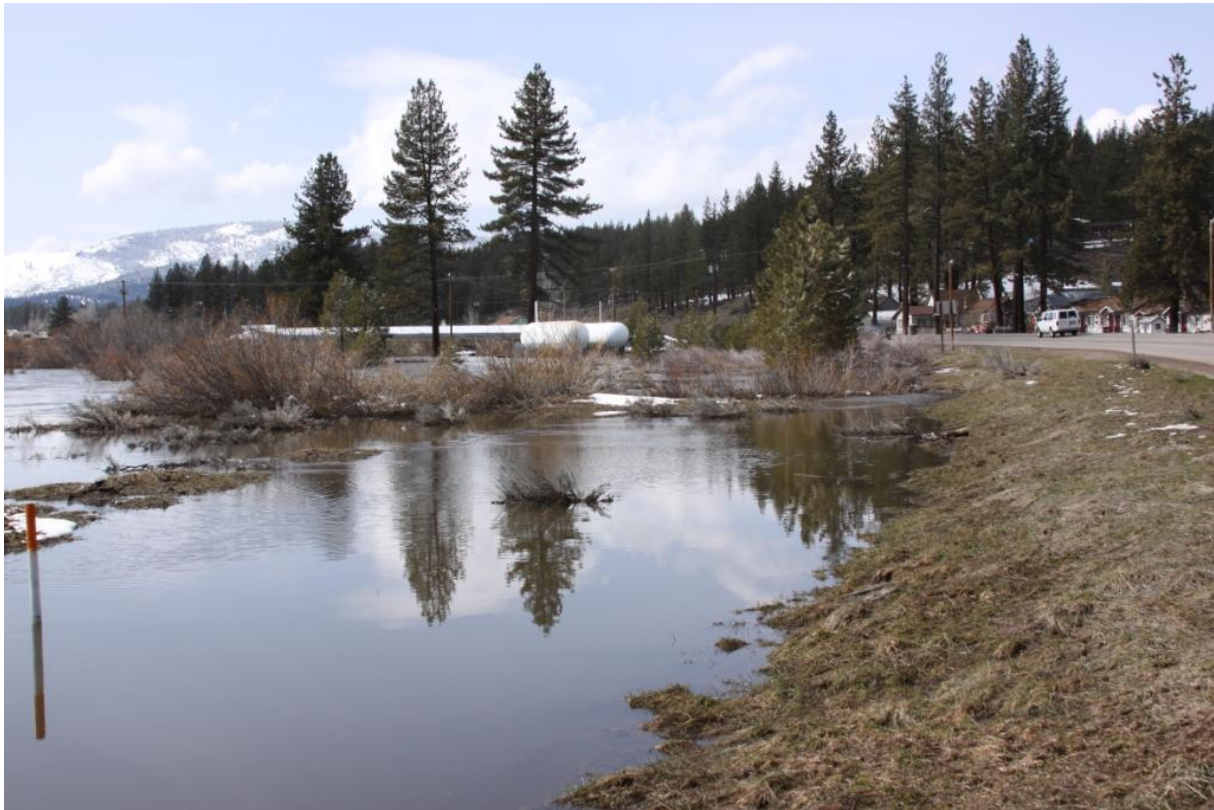
Photos: Middle Fork Feather River near Portola, CA: During 3/17/2011 High Water

View W (DS) from RB, @ CA Hwy 70 Mile Marker 75, DS. Propane tanks at center; Sleepy Pines Motel at right center. 3/17/2011, 2:45PM. Stage/flow @MFTC1 gage: 8.97'/4760 cfs.

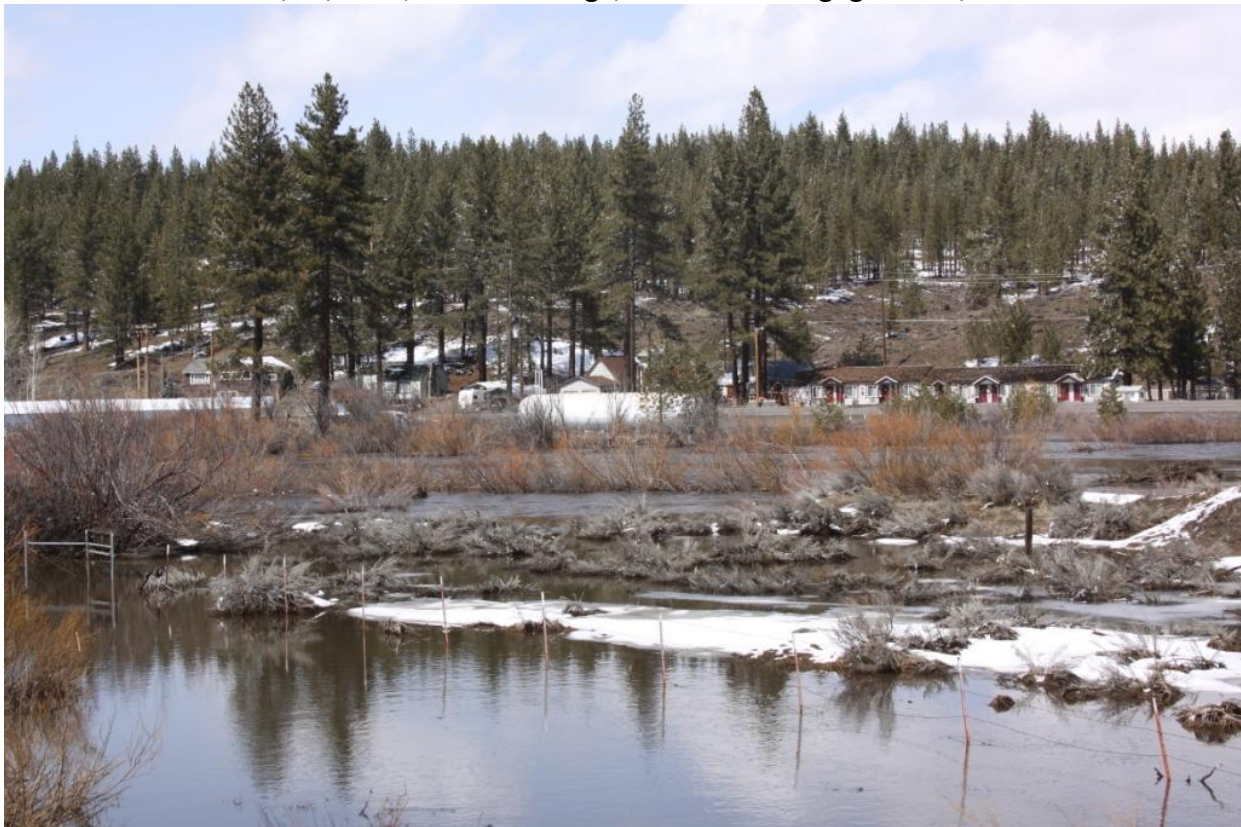
View to N from sewage ponds across river; note propane tanks at center, Sleepy Pines Motel at center right. 3/17/2011, 1:40PM. Stage/flow @MFTC1 gage: 8.99'/4790 cfs.

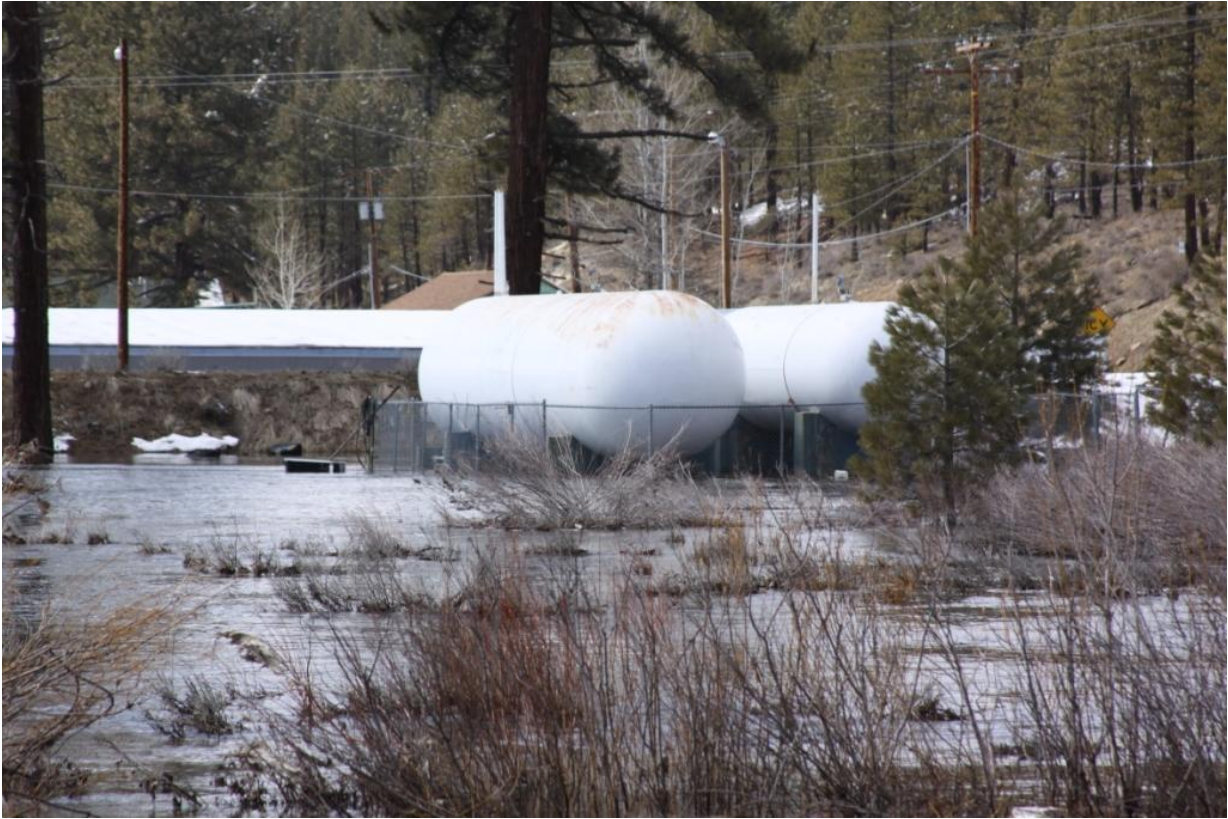
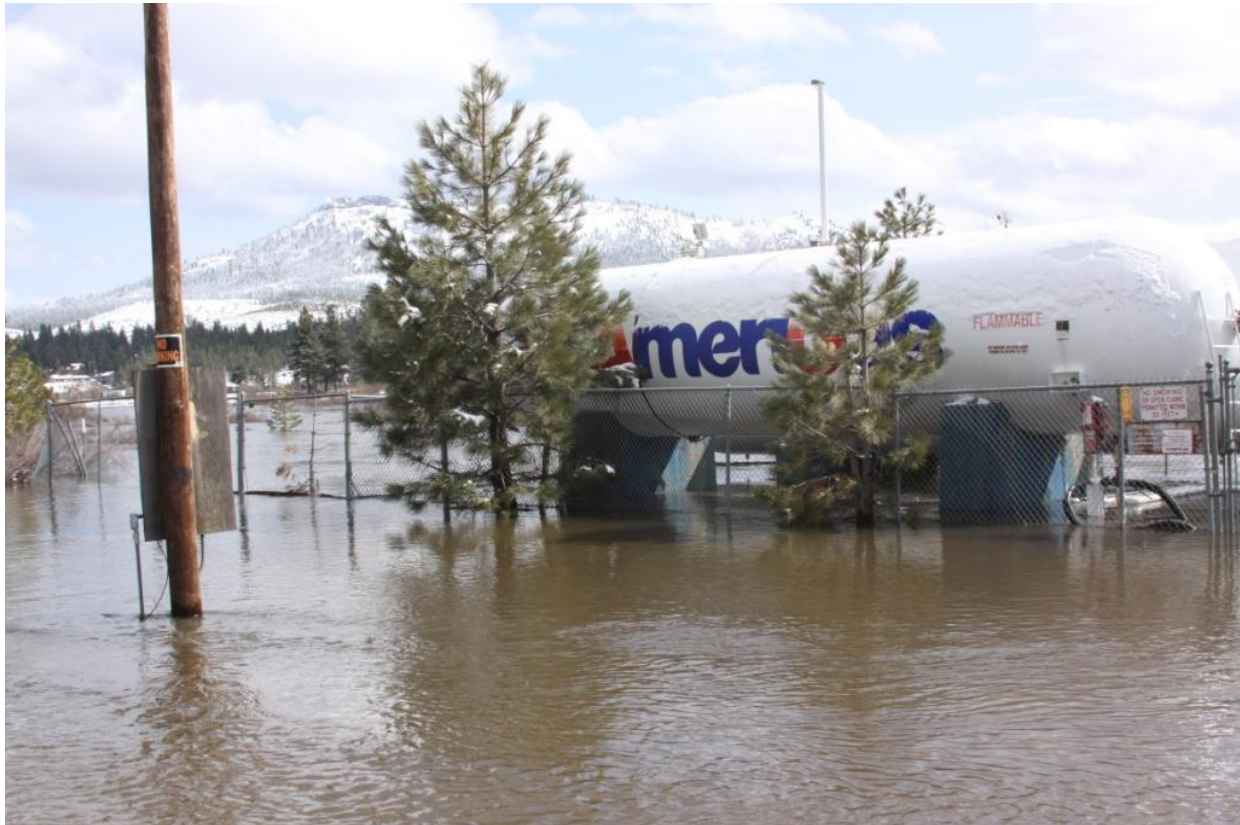
Photos: Middle Fork Feather River near Portola, CA: During 3/17/2011 High Water

Propane tanks surrounded by water; from near CA Hwy 70 Mile Marker 75. Top photo: view to WNW (looking DS). Bottom photo: view to ESE of tanks from near shoulder of CA Hwy 70. 3/17/2011, 2:45PM.

Stage/flow @MFTC1 gage: 8.97'/4760 cfs.

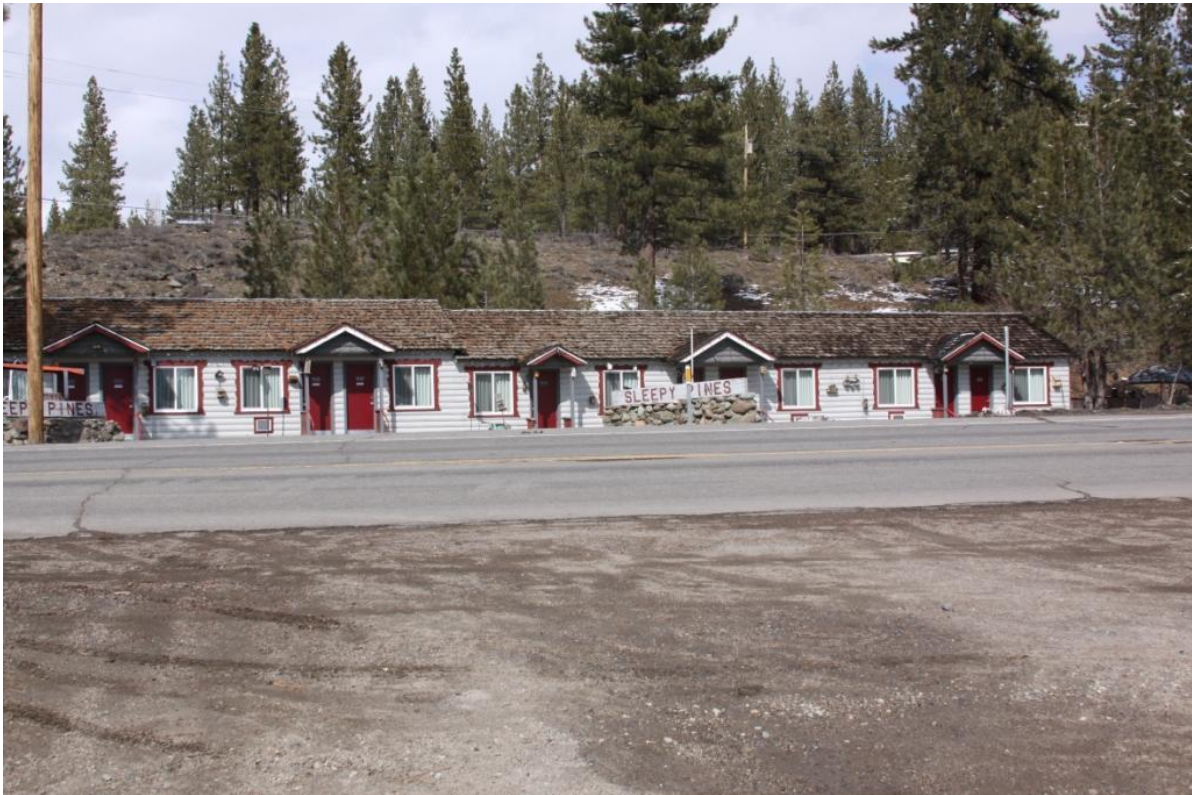
Photos: Middle Fork Feather River near Portola, CA: During 3/17/2011 High Water

View N to Sleepy Pines Motel from near river bank, just N of CA Hwy 70, below grade. Motel possibly subject to flooding near 9.5 ft @ MFTC1 gage. 3/17/2011, 2:55PM. Stage/flow @MFTC1 gage: 8.97'/4760 cfs.

9.50	Moderate flooding of lowlands...roads and low-lying structures in reach from Beckwourth to Sloat, California, including Portola. In Portola...Sleepy Pines Motel on CA Hwy 70 begins to experience some minor flooding. Water near bottom of large propane tanks along Hwy 70. South end of West Street flooded, nearing lowest homes. Sewage ponds in Portola at capacity. River within about a foot of foundation of Veterans Hall and some low homes along river. CA Hwy 89 near Clio flooded. Approx. 5600 cfs, like flood of 1/14/1980.

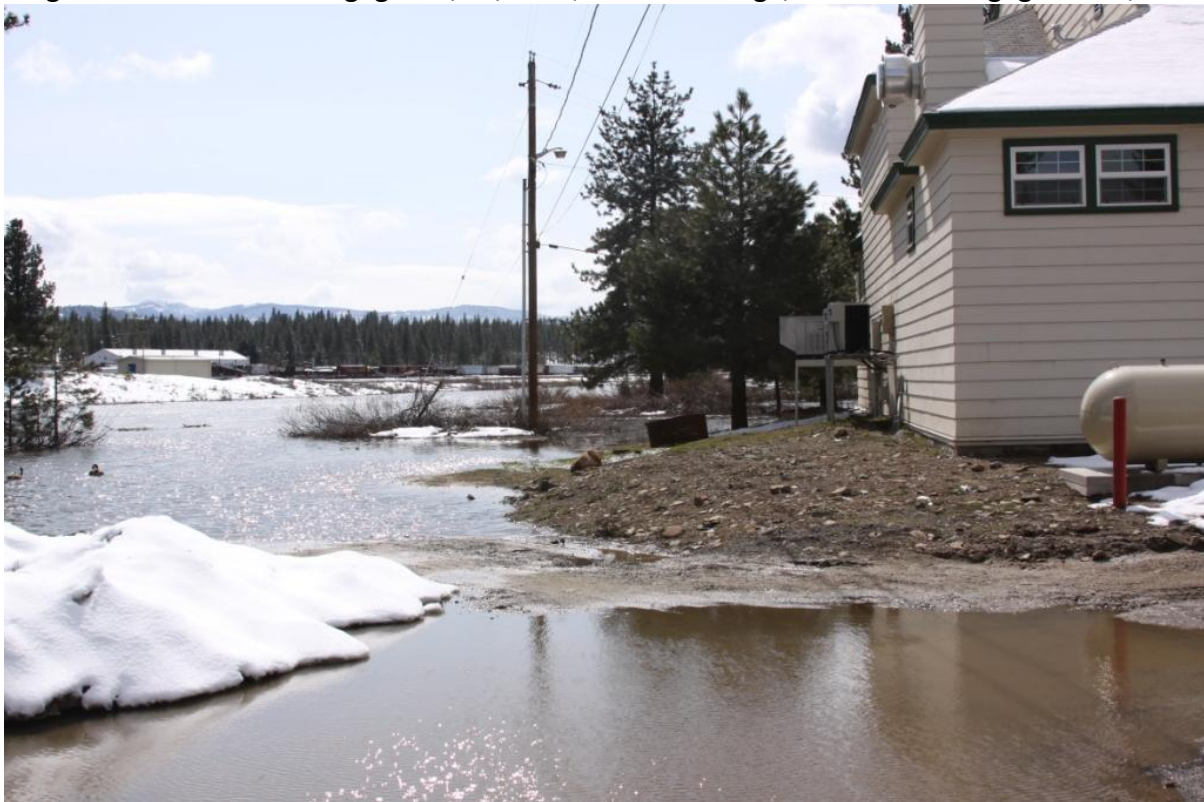
View SW to S and E walls of Portola Veteran's Memorial Hall on RB. Hall possibly subject to flooding at about 10.5 ft @ MFTC1 gage. 3/17/2011, 2:30PM. Stage/flow @MFTC1 gage: 8.97'/4760 cfs.

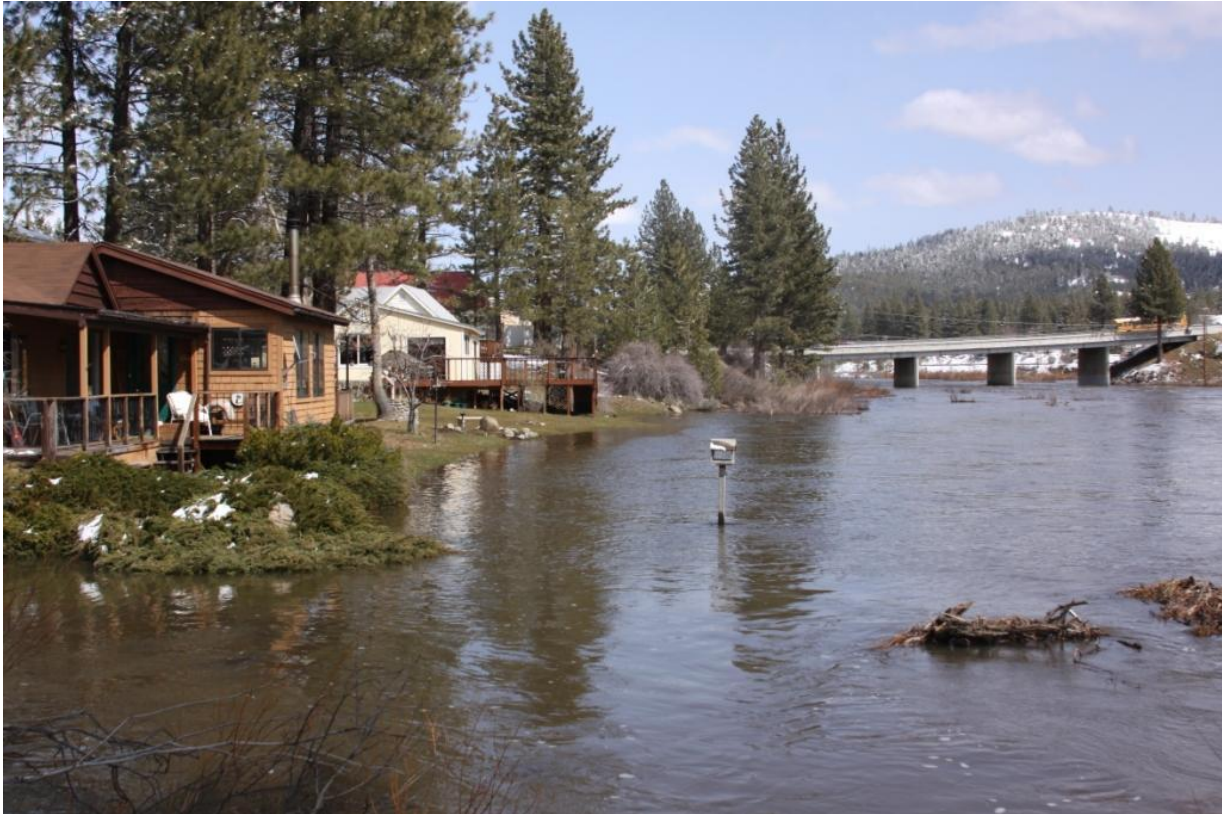
Photos: Middle Fork Feather River near Portola, CA: During 3/17/2011 High Water

View US (ENE) at some of lowest home subject to flooding in Portola. From S end of West Street along RB, about 0.2 mi DS of Gulling Street Bridge in Portola. 3/17/2011, 2:15PM. Stage/flow @MFTC1 gage: 8.97'/4760 cfs.

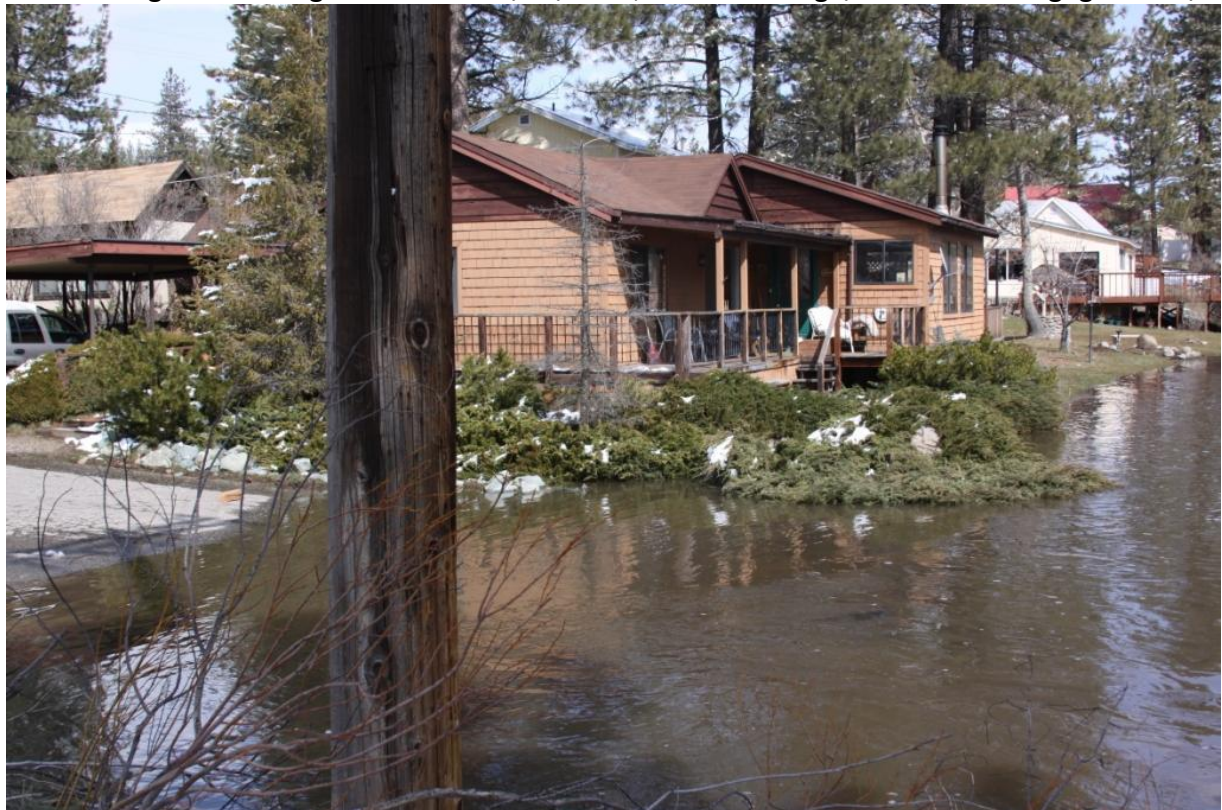
View of lowest home at S end of West Street, about 0.2 mi DS of Gulling Street Bridge in Portola. 3/17/2011, 2:15PM. Stage/flow @MFTC1 gage: 8.97'/4760 cfs.

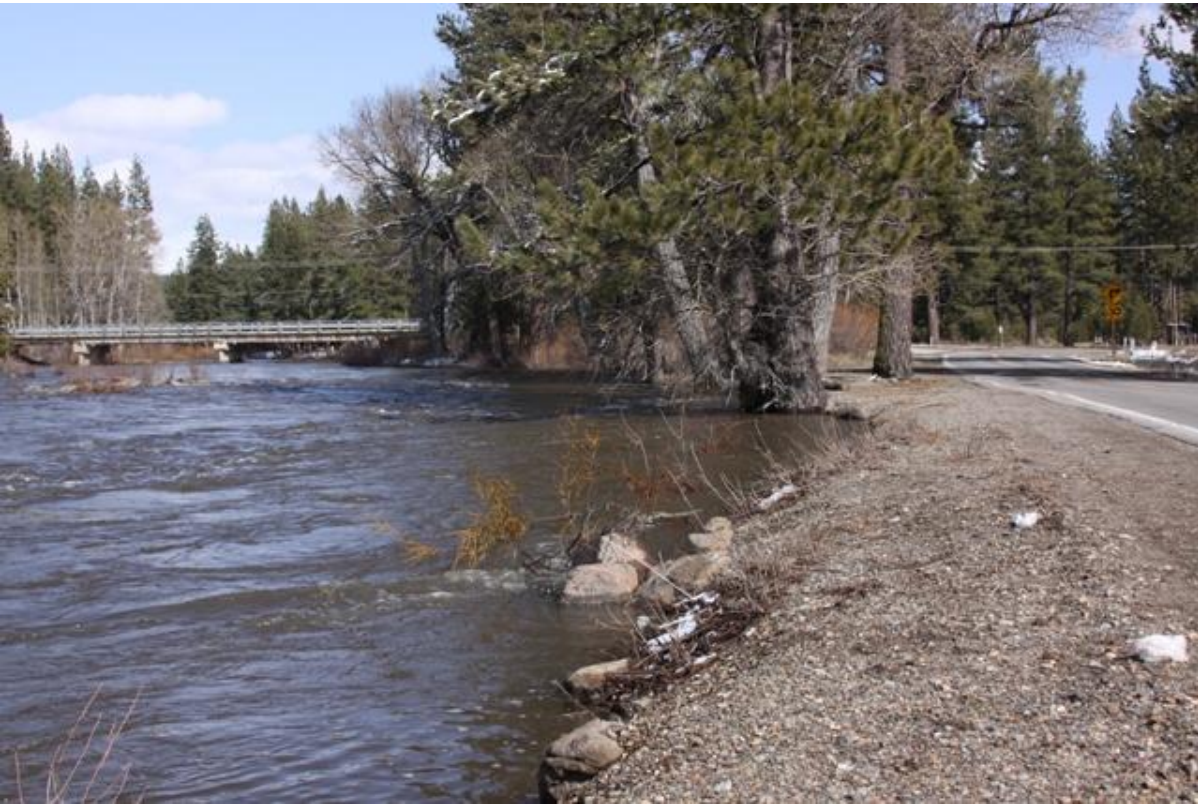
Photos: Middle Fork Feather River at Clio, CA During 3/17/2011 High Water

Looking US along LB (ENE) to Clio Bridge from shoulder of CA Hwy 89 nr Mile Marker 4.5 near Clio turn off.
3/17/2011, 3:40PM. Stage/flow @MFTC1 gage: 8.97'/4760 cfs.

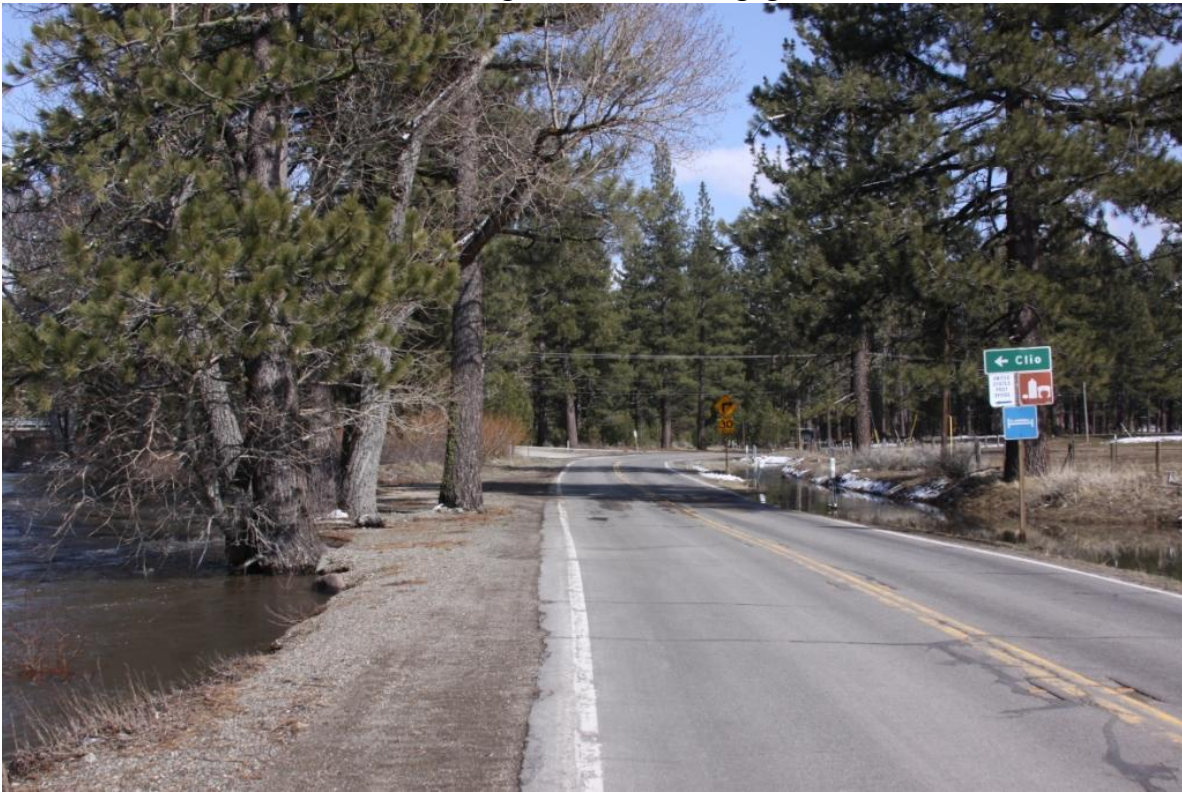
CA Hwy 89 nr Mile Marker 4.5 nr Clio turn off, view to E. River is on left, portion of Clio Bridge visible left center.
Note wet pavement where water floods road (due to culvert on right backed up to river) just beyond sign (right).
Flooding occurred here earlier this day. 3/17/2011, 3:40PM. Stage/flow @MFTC1 gage: 8.97'/4760 cfs.

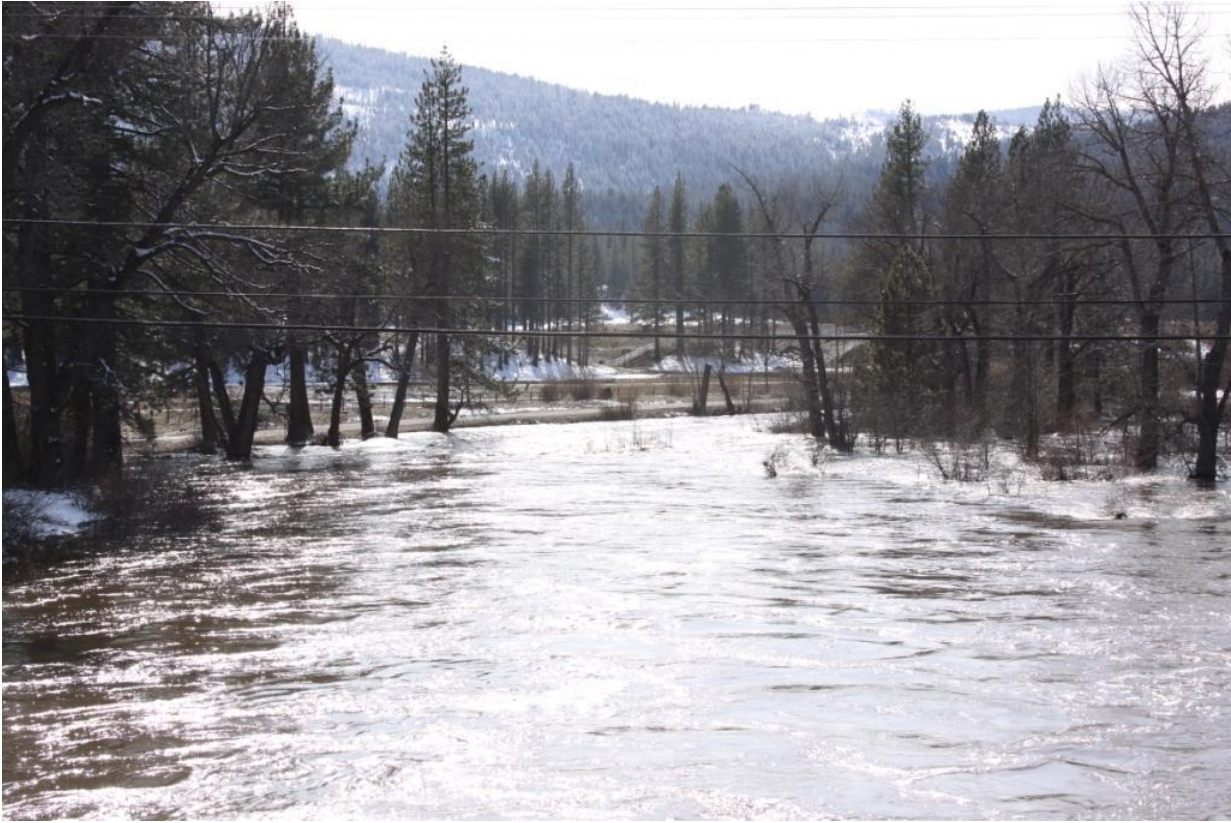
Photos: Middle Fork Feather River at Clio, CA During 3/17/2011 High Water

View DS (SW) along LB from Clio Bridge. Sharp bend to right in river just beyond trees. Town of Clio is out of picture to right. 3/17/2011, 4:05PM. Stage/flow @MFTC1 gage: 8.96'/4745 cfs.

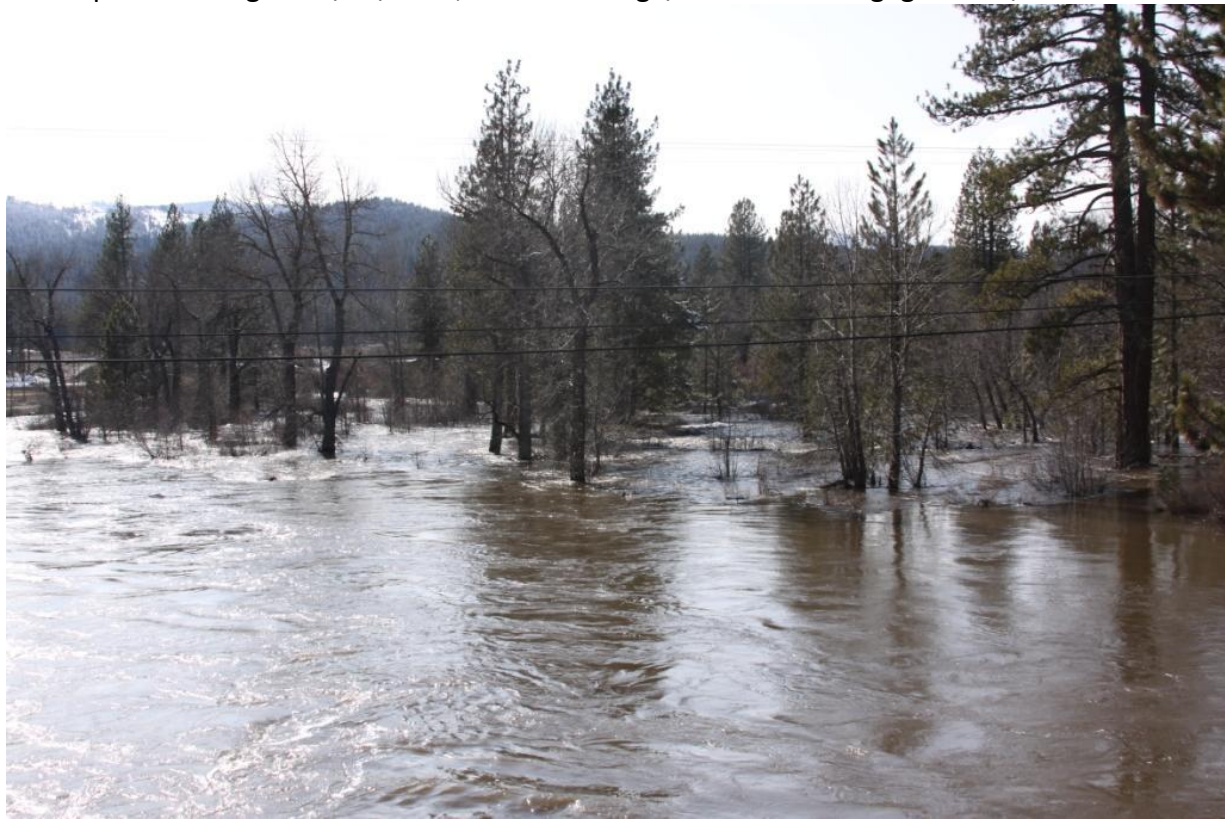
View DS (W) along RB from Clio Bridge. Center channel is on left, much of flow visible is overland flow. Town of Clio is out of picture to right. 3/17/2011, 4:05PM. Stage/flow @MFTC1 gage: 8.96'/4745 cfs.

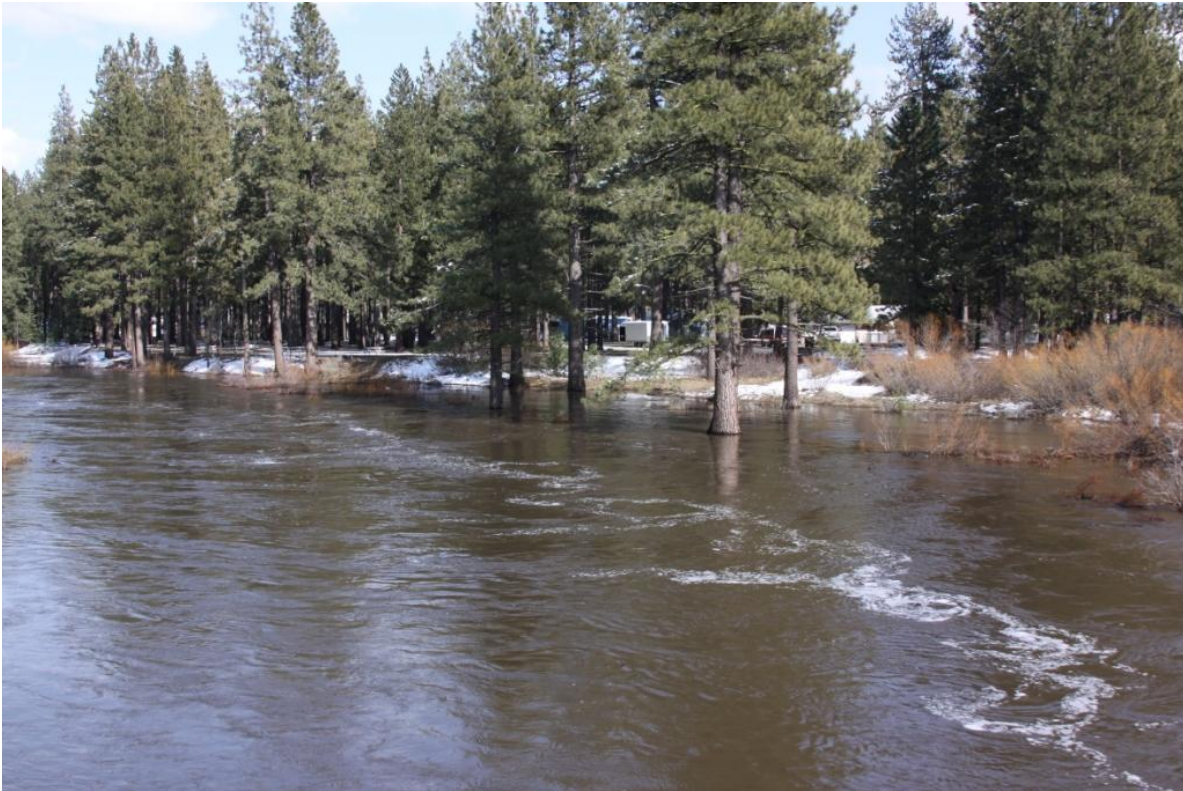
Photos: Middle Fork Feather River at Clio, CA During 3/17/2011 High Water

View US (E) along LB from Clio Bridge. Town of Clio is out of picture to left; note structures beyond trees.
3/17/2011, 4:05PM. Stage/flow @MFTC1 gage: 8.96'/4745 cfs.

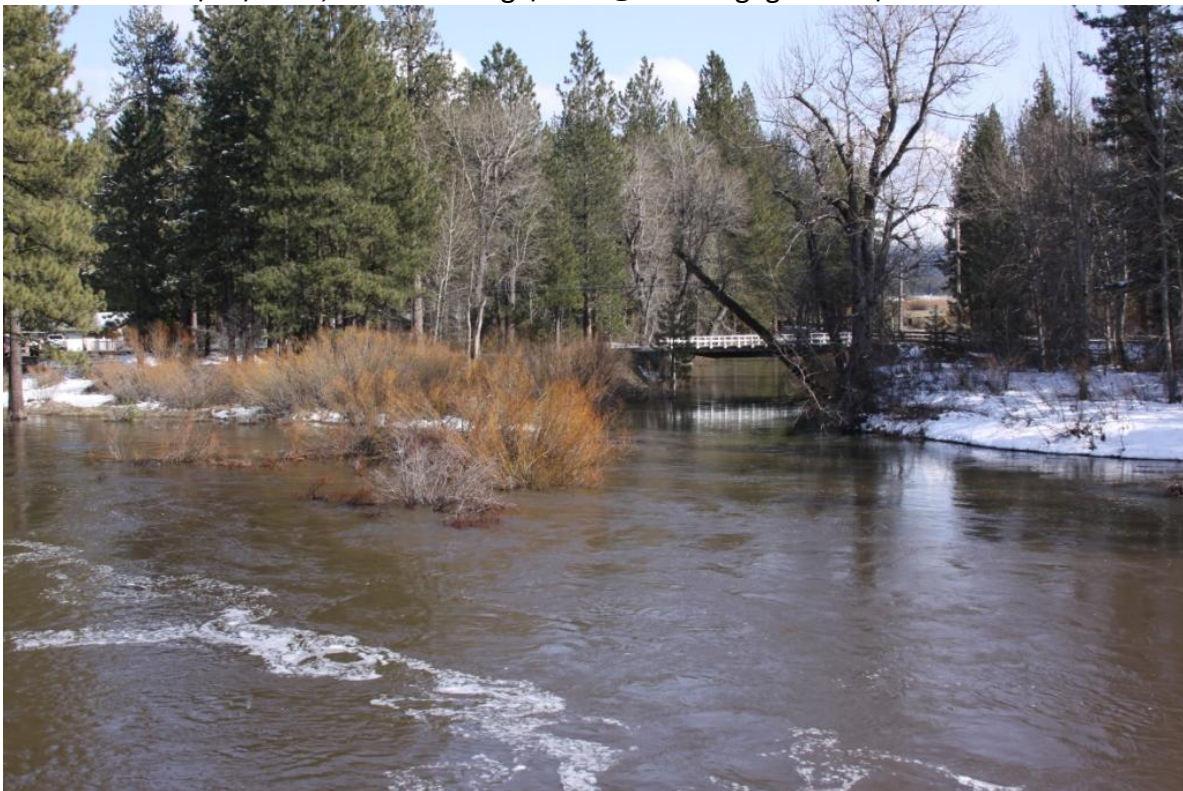
View of confluence of Sulfur Creek on LB, looking US from Clio Bridge toward the SE. 3/17/2011, 4:05PM.
Stage/flow @MFTC1 gage: 8.96'/4745 cfs.
